**SANITARY SEWER  
INSPECTION**

**LOCATION: DRISCOLL  
SCHOOL WILTON, CT**

**September 2012**

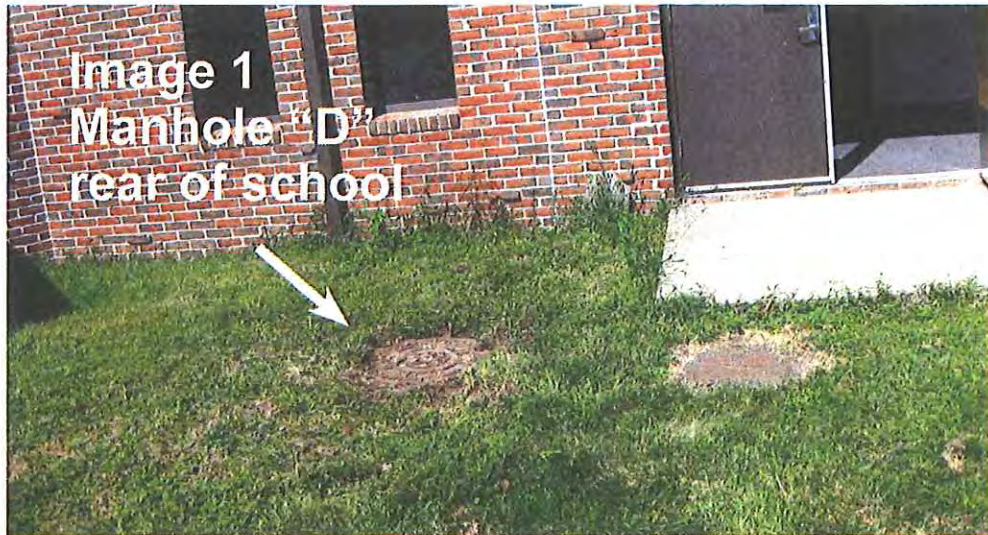
Our technician began the pipe inspection at manhole "D" at the rear of the school following the length of the 170' pipe and found it in good condition on August 22, 2012.  
(See image 1)

The video inspection concluded the line was clear with no visible line damage and/or obstructions. ACS recommends performing additional video inspection in 6 months to further observe any changes in sewer line.

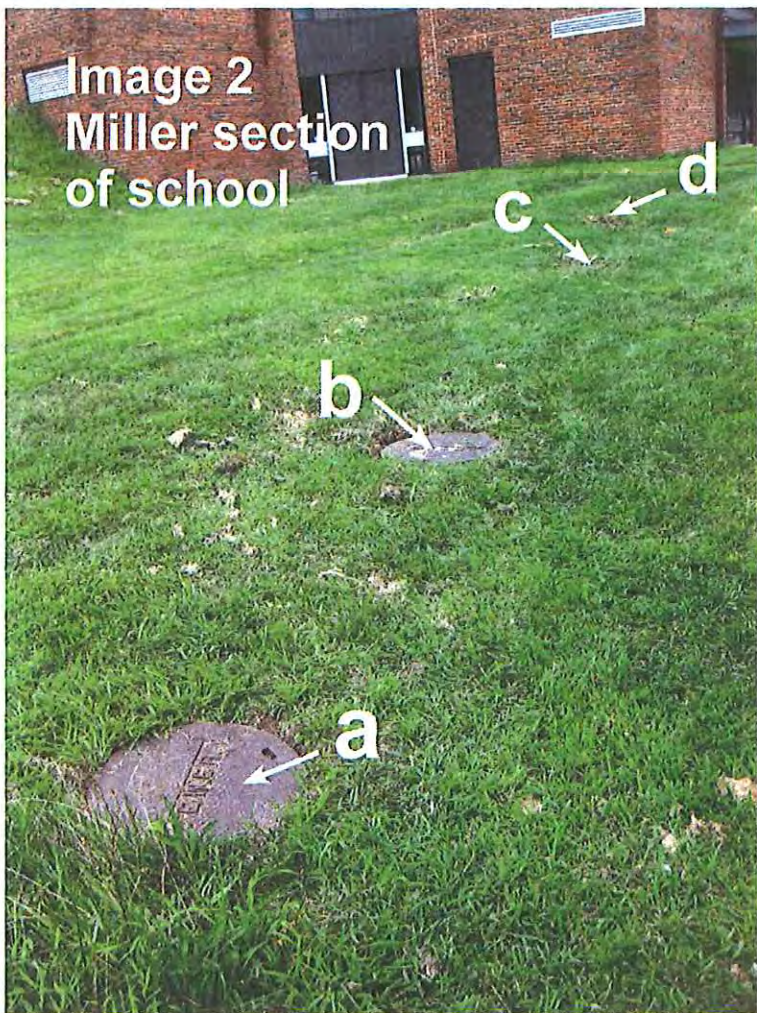
ACS went on to inspect another section of the pipe at the Miller section of the school. Four manhole covers were lifted and observed with site supervisor. (See image 2 [a,b,c,d]) Out of the four manholes (a, b) were filled with water (c) the clean out would not open (d) was at full flow. Site supervisor advised technician that this was normal flow and there was no need to video inspect this section as blockages or backups had never occurred on this line before.
